# Management Survey

Queen Street Nursery  
Falkirk  
FK2 7AF

Report issue date:	26 June 2014

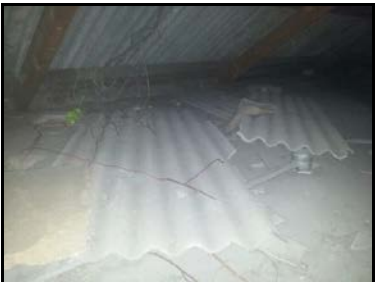
Sample No	Building	Floor	Analysis
	P-130173/001	Queen Street Nursery	First Floor	Chrysotile
	Area/Location/Position	Material description	Quantity	Confirmation of product type
	004 - Ceiling void - Loose cement panels in ceiling void space	Cement product	2 m <sup>2</sup>	Asbestos cement
	Product type	Condition	Surface Treatment	Asbestos type
	1	1	1	1
	Material Risk Score	Priority Risk Score	Total Risk Score	Accessibility
4	-	4	1 - Occasional disturbance	
Recommended action	Remove – NLW			
Recommendation comments	-			
Surveyor comments	-

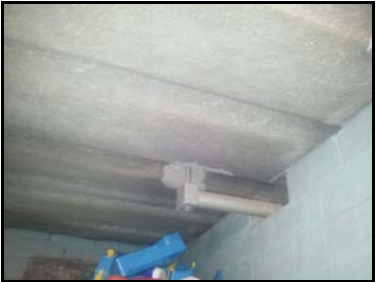
Sample No	Building	Floor	Analysis
	P-130173/002	Queen Street Nursery	Ground Floor	Chrysotile
	Area/Location/Position	Material description	Quantity	Confirmation of product type
	001 - Store 1 - Cement ceiling panels to small to cubicle area	Cement product	48 m <sup>2</sup>	Asbestos cement
	Product type	Condition	Surface Treatment	Asbestos type
	1	1	1	1
	Material Risk Score	Priority Risk Score	Total Risk Score	Accessibility
4	-	4	1 - Occasional disturbance	
Recommended action	Monitor condition			
Recommendation comments	-			
Surveyor comments	-

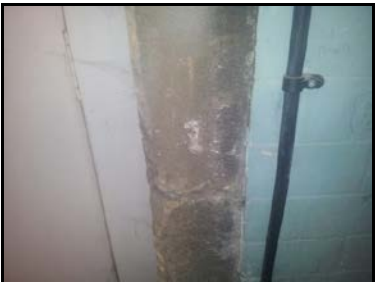
Sample No	Building	Floor	Analysis
	P-130173/003	Queen Street Nursery	Ground Floor	No asbestos detected
	Area/Location/Position	Material description	Quantity	Confirmation of product type
	001 - Store 1 - Small area of mastic to wall at right hand side of door	Mastics	N/A	Non-asbestos material
	Product type	Condition	Surface Treatment	Asbestos type
	-	-	-	-
	Material Risk Score	Priority Risk Score	Total Risk Score	Accessibility
0	-	0	-	
Recommended action	-			
Recommendation comments	-			
Surveyor comments	-

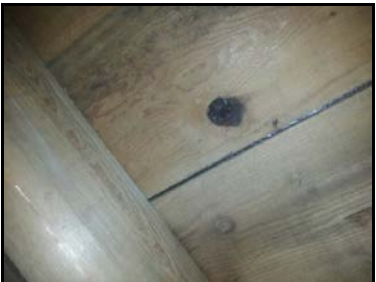
Sample No	Building	Floor	Analysis
	P-130173/004	Queen Street Nursery	Ground Floor	No asbestos detected
	Area/Location/Position	Material description	Quantity	Confirmation of product type
	002 - Store 2 - Roof felt above timber sarking boards	Bituminous products	N/A	Non-asbestos material
	Product type	Condition	Surface Treatment	Asbestos type
	-	-	-	-
	Material Risk Score	Priority Risk Score	Total Risk Score	Accessibility
0	-	0	-	
Recommended action	-			
Recommendation comments	-			
Surveyor comments	-

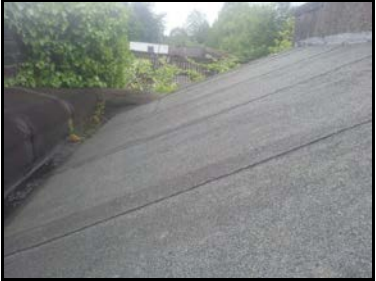
Sample No	Building	Floor	Analysis
	P-130173/005	Queen Street Nursery	External	No asbestos detected
	Area/Location/Position	Material description	Quantity	Confirmation of product type
	003 - Externals - Bitumen felt to roof of store 2	Bituminous products	N/A	Non-asbestos material
	Product type	Condition	Surface Treatment	Asbestos type
	-	-	-	-
Material Risk Score	Priority Risk Score	Total Risk Score	Accessibility	
0	-	0	-	
Recommended action	-			
Recommendation comments	-			
Surveyor comments	-

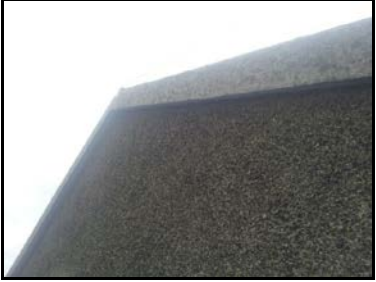
Sample No	Building	Floor	Analysis
	P-130173/006	Queen Street Nursery	External	Chrysotile
	Area/Location/Position	Material description	Quantity	Confirmation of product type
	003 - Externals - Cement flashing to roof apex	Cement product	8 m linear	Asbestos cement
	Product type	Condition	Surface Treatment	Asbestos type
	1	1	1	1
Material Risk Score	Priority Risk Score	Total Risk Score	Accessibility	
4	-	4	0 - Usually inaccessible	
Recommended action	Monitor condition			
Recommendation comments	-			
Surveyor comments	-

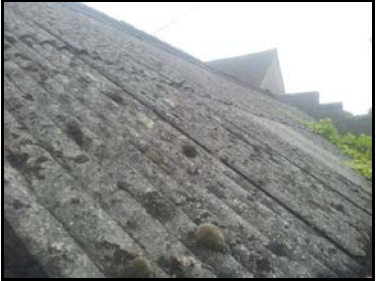
Sample No	Building	Floor	Analysis
	P-130173/007	Queen Street Nursery	External	Chrysotile
	Area/Location/Position	Material description	Quantity	Confirmation of product type
	003 - Externals - Cement roof sheets	Cement product	96 m <sup>2</sup>	Asbestos cement
	Product type	Condition	Surface Treatment	Asbestos type
	1	1	1	1
Material Risk Score	Priority Risk Score	Total Risk Score	Accessibility	
4	-	4	0 - Usually inaccessible	
Recommended action	Monitor condition			
Recommendation comments	-			
Surveyor comments	-

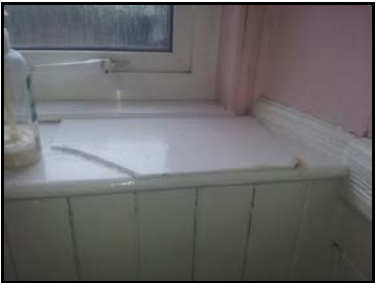
Sample No	Building	Floor	Analysis
	P-130173/008	Queen Street Nursery	Ground Floor	Chrysotile
	Area/Location/Position	Material description	Quantity	Confirmation of product type
	005 - Toilet in Heads office - Cement panel on window sill	Cement product	1 Number	Asbestos cement
	Product type	Condition	Surface Treatment	Asbestos type
	1	1	1	1
Material Risk Score	Priority Risk Score	Total Risk Score	Accessibility	
4	-	4	2 - Easily disturbed	
Recommended action	Monitor condition			
Recommendation comments	-			
Surveyor comments	-

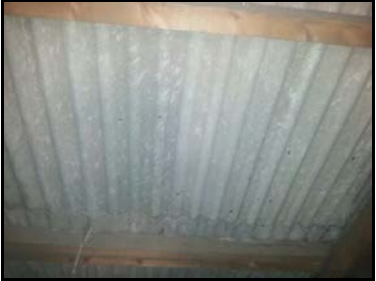
Sample No	Building	Floor	Analysis
	P-130173/As 007	Queen Street Nursery	First Floor	Strongly Presumed Chrysotile
	Area/Location/Position	Material description	Quantity	Confirmation of product type
	004 - Ceiling void - Cement roof panels	Cement product	96 m <sup>2</sup>	Strongly Presumed Asbestos cement
	Product type	Condition	Surface Treatment	Asbestos type
	1	1	1	1
	Material Risk Score	Priority Risk Score	Total Risk Score	Accessibility
4	-	4	0 - Usually inaccessible	
Recommended action	Monitor condition			
Recommendation comments	-			
Surveyor comments	Underside of roof sheets.

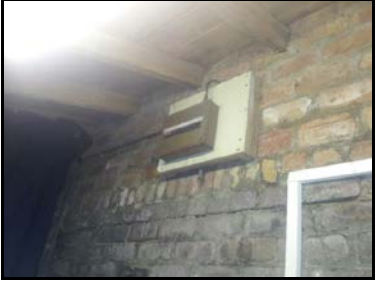
Sample No	Building	Floor	Analysis
	P-130173/P001	Queen Street Nursery	Ground Floor	Presumed to contain asbestos
	Area/Location/Position	Material description	Quantity	Confirmation of product type
	002 - Store 2 – Flash guards in old electrical box	Woven product	Unknown Number	N/A
	Product type	Condition	Surface Treatment	Asbestos type
	2	0	1	3
	Material Risk Score	Priority Risk Score	Total Risk Score	Accessibility
6	-	6	1 - Occasional disturbance	
Recommended action	Monitor condition			
Recommendation comments	-			
Surveyor comments	No sample taken due to live electrics. Limited inspection to this area due to large amount of items stored.
